Driveability
And
Service:
Typhoon And
Syclone

REFERENCE #GMCTT-92-06-2

REFERENCE
MANUAL

LEADER GUIDE

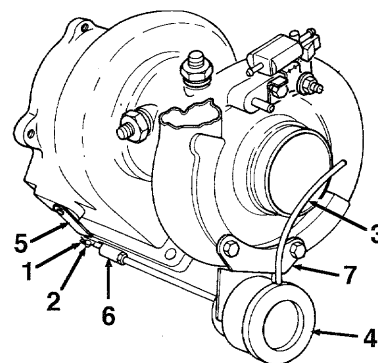
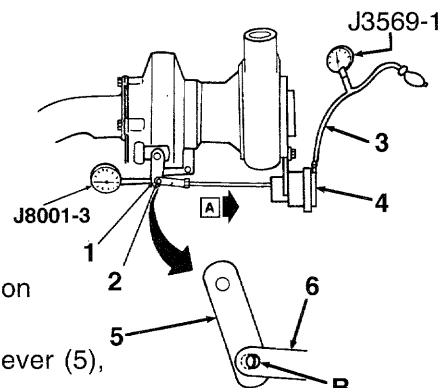
Do not attempt to adjust the wastegate actuator outside the range of the specifications in this procedure. Improper adjustment can severely limit performance or cause over-boost, resulting in fuel shut off.

- 1 Remove right front wheel and tire.
- 2 Remove the passenger side wheelhouse panel.
- 3 Disconnect the retaining wire (1) from pin (2).
- 4 Remove special clamp (7) from boost control hose.
- 5 Disconnect boost control hose (3) from wastegate actuator (4).

- 1 Connect pressure gage, tool J 35691, to hose connection on wastegate actuator (4) making sure dial reads zero.
- 2 Connect the dial indicator, tool J 8001-3, on end of the lever (5), making sure dial reads zero.

- 3 Apply 31 to 34.5 kPa (4.5 to 5 psi) air pressure with the tool J 35691 and check tool J 8001-3 for pressure reading.
- 4 If the dial indicator, tool J 8001-3, reads greater than 0.5 mm to 1.5 mm (0.02 to 0.06 inch), readjust rod by shortening it a half-turn at rod end (6). If J 8001-3 reads less than 0.5 mm to 1.5 mm (0.02 to 0.06 inch), readjust rod by lengthening it a half-turn at rod end (6).

- 5 Recheck travel at 31 to 34.5 Kpa (4.5 to 5 psi) air pressure.
- 6 Repeat the adjustment until above specifications are met. If specifications can not be met, replace the wastegate actuator.

- 7 If adjustment causes wastegate to open at all, replace wastegate actuator
- 8 Remove tools J 8001-3 and J 35691.

- 1 Install new clamp (7) on boost control hose (3).
- 2 Connect the boost control hose (3) to wastegate actuator (4).
- 3 Correctly position clamp on hose end and crimp clamp onto hose. Clamp must prevent hose from being capable of pulling off actuator.
- 4 Connect the retaining wire (1) to pin (2).
- 5 Install the passenger side wheelhouse panel.

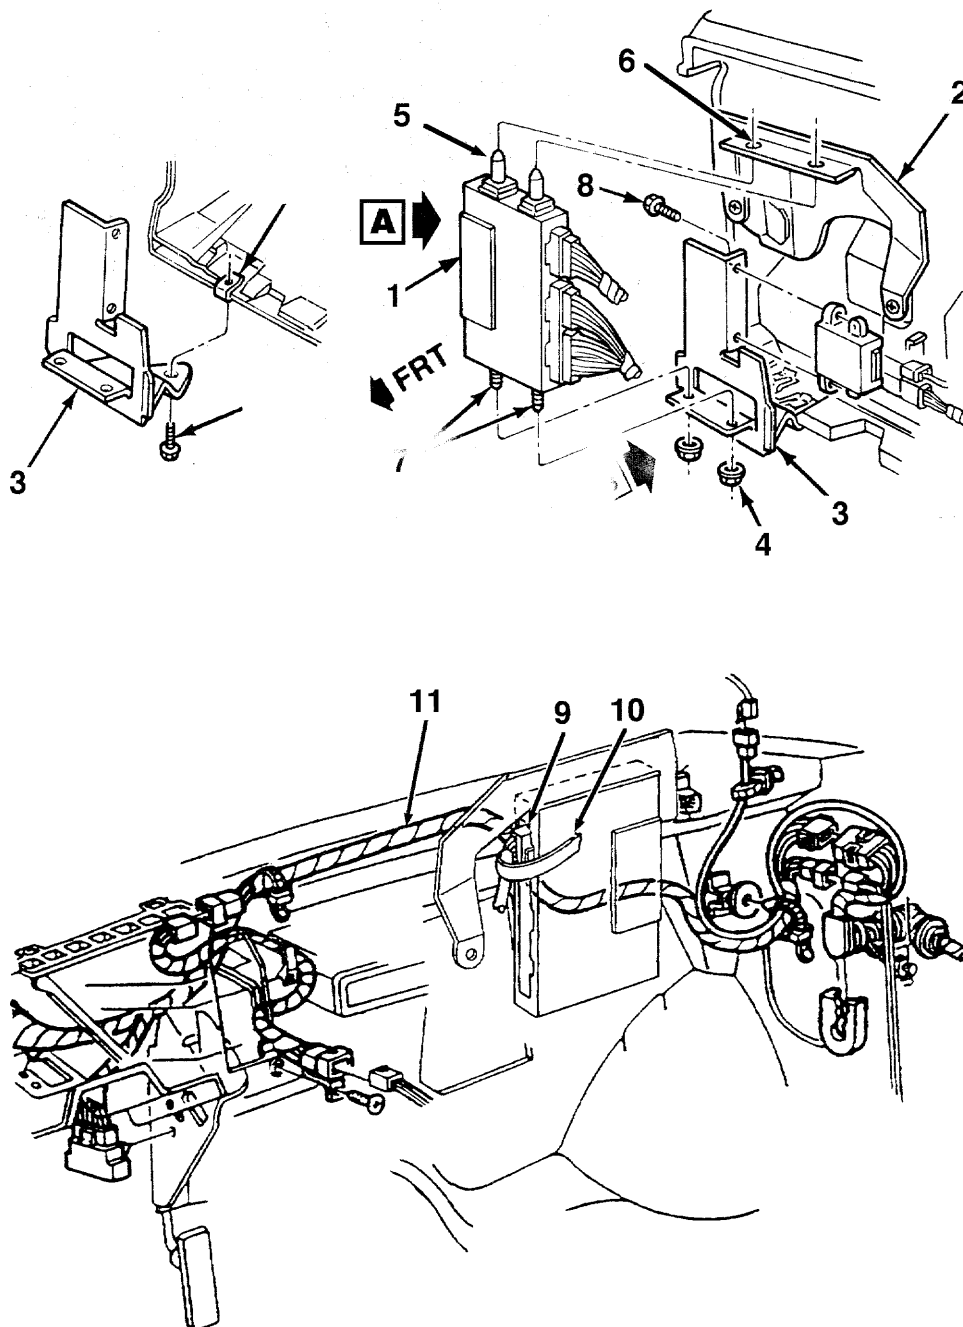
H ECM CHAFFING/ECM REPLACEMENT

Sycloones built before VIN 1521 may experience overboost due to ECM wiring harness chaffing against the upper mounting bracket. It is necessary to repair the wires and install a new mounting bracket assembly to correct this condition.

- 1 Disconnect the negative (-) battery cable.
- 2 Disconnect wiring harness.
- 3 Remove the ECM from the upper bracket.
- 4 Remove the upper mounting bracket.
- 5 Repair the "chaffed" wiring harness in the approved GM manner.

- 1 Mount upper mounting bracket (2) to the I.P.
- 2 When installing the ECM into the passenger compartment position the wire out of the top (green) connector (9) between the connector thumb latch and the tab on grey comb. Place tape (10) to retain wire in this position during ECM installation. To avoid interference, it will be necessary to move the cross body power door lock harness (11) prior to ECM installation.
- 3 Mount ECM (1) into the upper mounting bracket (2) by inserting the ECM mounting pins (5) into the upper bracket mounting holes (6).

- 4 Secure the lower mounting bracket (3) to the I.P. using the lower mounting bracket mounting bolt (8).
- 5 Install right hush panel.
- 6 Reconnect negative (-) battery cable.
- 7 Verify all ECM functions with a Tech Scan tool.

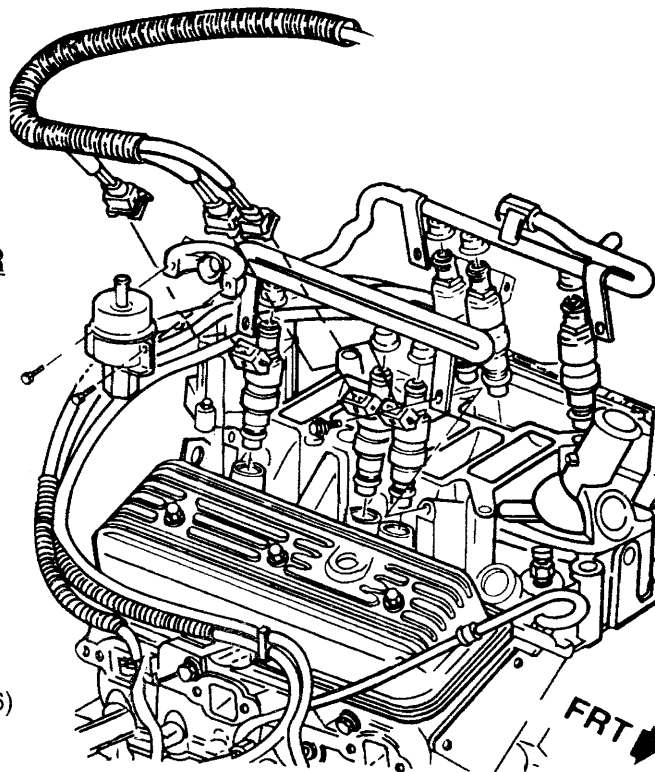
- Injector noise is caused by the fuel rails seated too close to the engine causing the fuel injectors to contact the intake manifold. The repair procedure involves raising the height of the fuel rail, thus relieving the metal to metal contact of the fuel injectors to the manifold. This depressed fuel rail condition can also cause the fuel to boil in the fuel rail because heat is transferred directly from the intake manifold through the injectors to the rail. This can cause poor engine performance.

- 1 On a cool engine loosen the passenger side fuel rail brackets (1).
- 2 Then loosen the driver side fuel rail brackets (2).
- 3 Raise the passenger side fuel rail as far as the bracket slots (1) permit, tighten the bolts.
- 4 Raise the driver side fuel rail as far as the fuel rail bracket (2) permits, tighten the bolts. This should correct the injector noise and heated fuel rail condition.

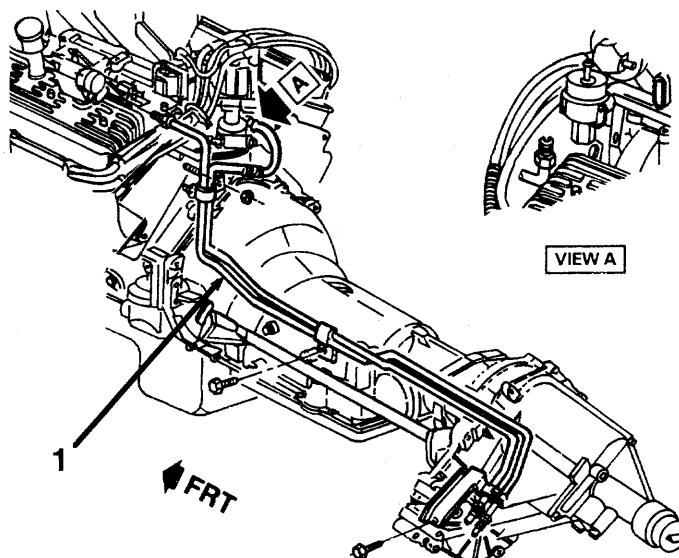
(1) Fuel Lines

■ Complaint: Customer may complain about noise (tapping sound) coming from the lower I.P. area.

- 1 Fuel lines (1) improperly routed over the transmission — there is too much clearance above the transmission and they are vibrating against the floor pan.

Correction: Adjust fuel line to achieve proper clearance from both the floor pan and the transmission.

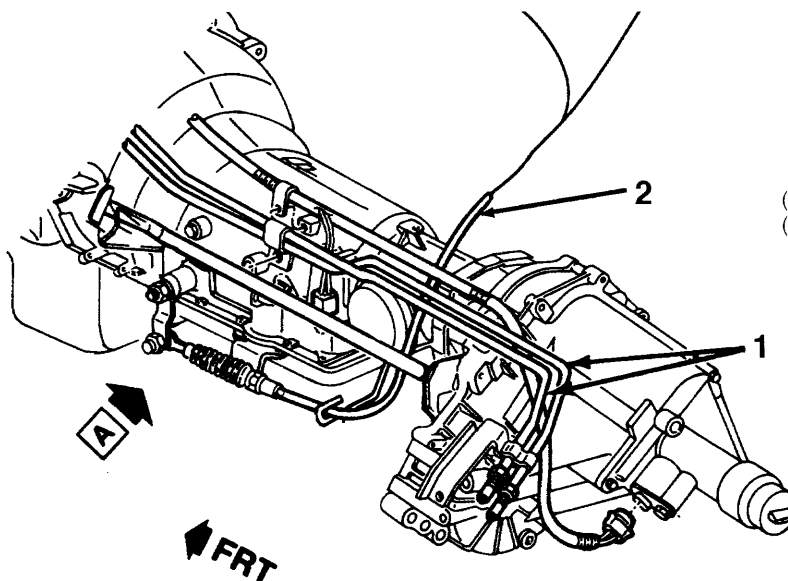
(1) Fuel Lines
(2) Shift Cables

- 2 Fuel line is vibrating against the shift cable.

Correction: Adjust fuel line to achieve clearance from the shift cable.

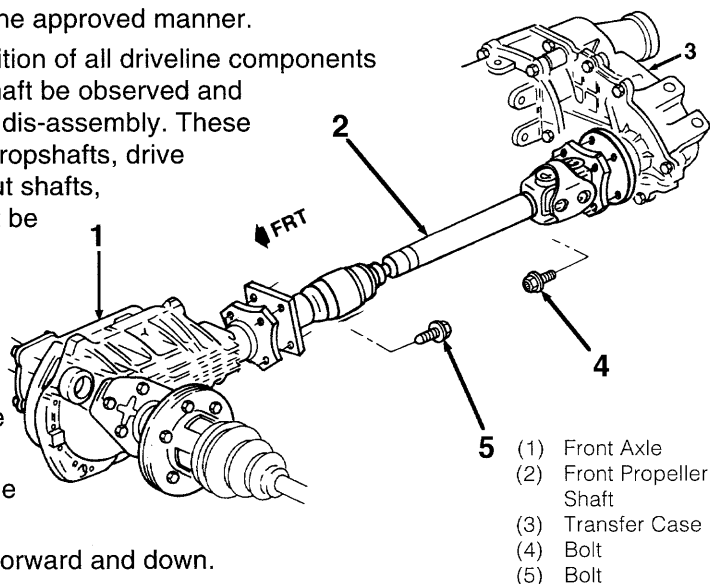
- Due to tooling problems, some seals have split at the clamp edge. Remove and replace the entire propshaft.

- 2 Remove the bolts (4) from the flange at the transfer case (3).

- 3 Remove the bolts (5) from the flange at the front axle (1).

- 5 Install the new front propshaft.

- 6 Install and tighten bolts (4) at the transfer case.

- 7 Install and tighten bolts (5) at the front axle.

NOTE: Tighten all bolts of 70 N.m (52 feet pounds)

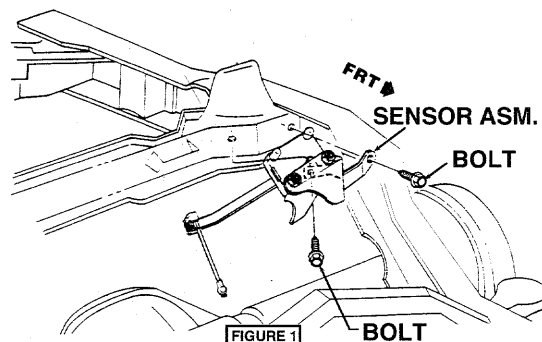
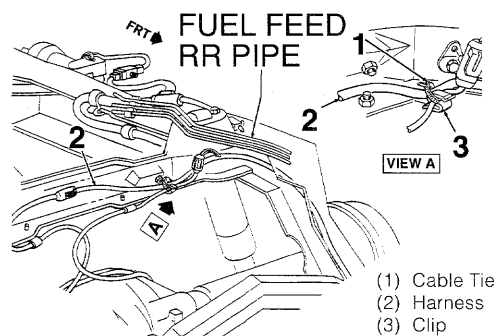
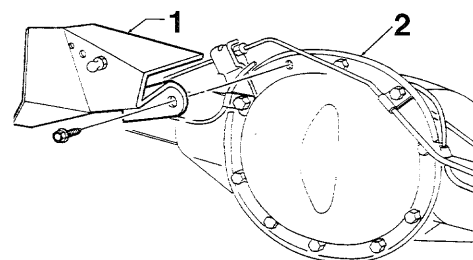
- PAS Inc., the final stage manufacturer of the 1992 GMC Typhoon, has determined that a defect which relates to motor vehicle safety exists in certain early built 1992 GMC Typhoons. The Electronic Level Control (ELC) sensor link may become disconnected from the ELC sensor assembly arm and the sensor arm could then become captured between the rear axle assembly and the right rear brake line near the junction block. In this position, normal suspension movement can cause the arm to wear through the rear brake line resulting in a loss of rear braking. If this occurs, the front braking would remain functional; however, a reduction of braking ability at a time when a minimum stopping distance is required could result in a vehicle crash without prior warning. To correct this condition, it will be necessary to install a revised ELC system. Additionally, the brake pipe and ABS wire will be inspected for signs of damage and replaced if necessary.

- 1 Raise and support the vehicle on a hoist.
- 2 Inspect brake line assembly in area of ELC (electronic level control) system for signs of abrasion or gouging. If any is noted, brake lines should be replaced following the procedures in service manual X-9229, Section 5A.

- 3 Inspect the wiring harness to both rear wheel speed sensors for signs of damage. If any is noted, replace the affected rear wheel speed sensor assembly according to procedures in service manual X-9229, Section 5E1.

- 4 Remove entire ELC sensor control system assembly (Figure 1).
- 5 Arrange ABS wheel speed sensor wires as shown in Figure 2. Tie wrap as shown in View A, Figure 2.

- 6 Install new level sensor assembly using the existing bracket mounting bolts. Be sure to check that the wiring harnesses in the area around the level sensor assembly are not pinched. Refer to Figure 2 for proper wiring harness placement. Torque mounting bolts to 14-20 N.m. (10-15 lbs. ft.) (Figure 1).

- 7 Remove the old axle bracket and loosely install the new axle bracket using existing mounting bolt (Figure 3).
