**GMC**

**SYCLONE**

**MASTER TECHNICIAN  
OVERVIEW**

## **LEADER GUIDE**

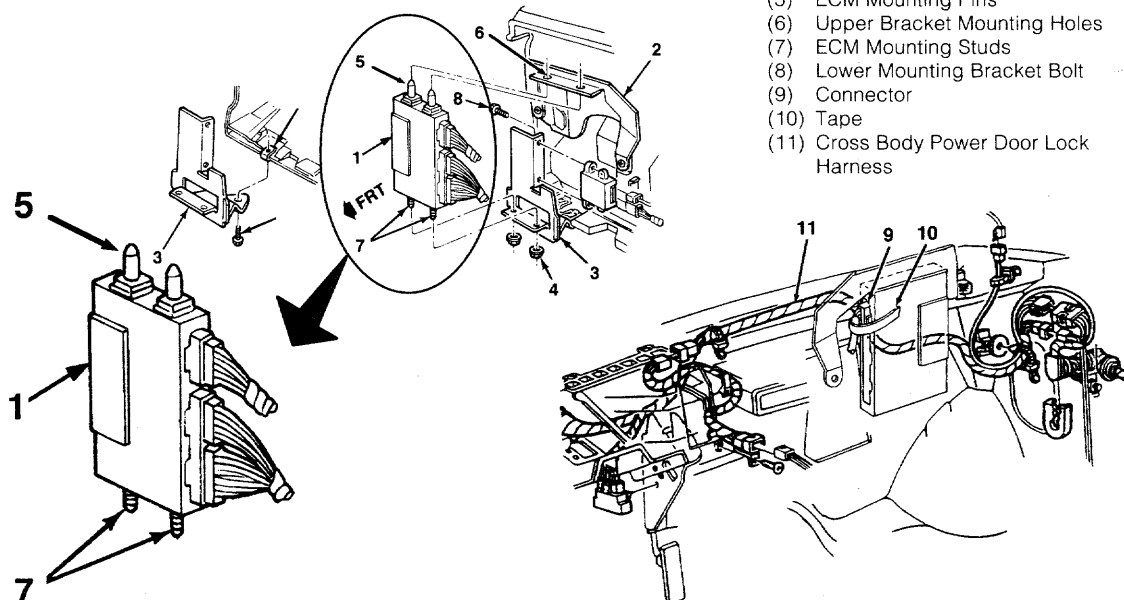
- (1) ECM Assembly
- (2) Upper Mounting Bracket
- (3) Lower Mounting Bracket
- (4) Nut
- (5) ECM Mounting Pins
- (6) Upper Bracket Mounting Holes
- (7) ECM Mounting Studs
- (8) Lower Mounting Bracket Bolt
- (9) Connector
- (10) Tape
- (11) Cross Body Power Door Lock Harness

Syclones built before VIN 1521 may experience overboost due to ECM wiring harness chaffing against the upper mounting bracket. It is necessary to repair the wires and install a new mounting bracket assembly to correct this condition. (Campaign 91-C-12.) NOTE: Normally this chaffing occurs with the green/white to black wire.

- 1 Disconnect the negative (-) battery cable.
- 2 Disconnect ECM wiring harness.
- 3 Remove the ECM from the upper bracket.
- 4 Remove the upper mounting bracket.
- 5 Repair the "chaffed" wiring harness in the approved GM manner.

- 1 Mount upper mounting bracket (2) to the I.P.
- 2 When installing the ECM into the passenger compartment, position the wire out of the top (green) connector (9) between the connector thumb latch and the tab on grey comb. IMPORTANT: Place tape (10) to retain wire in this position during ECM installation. To avoid interference, it will be necessary to move the cross body power door lock harness (11) prior to ECM installation.
- 3 Mount the ECM (1) into the upper mounting bracket (2) by inserting the ECM mounting pins (5) into the upper bracket mounting holes (6).
- 4 Secure the lower mounting bracket (3) to the I.P. using the lower mounting bracket mounting bolt (8).
- 5 Install right hush panel.
- 6 Reconnect negative (-) battery cable.
- 7 Verify all ECM functions with a Tech Scan tool.

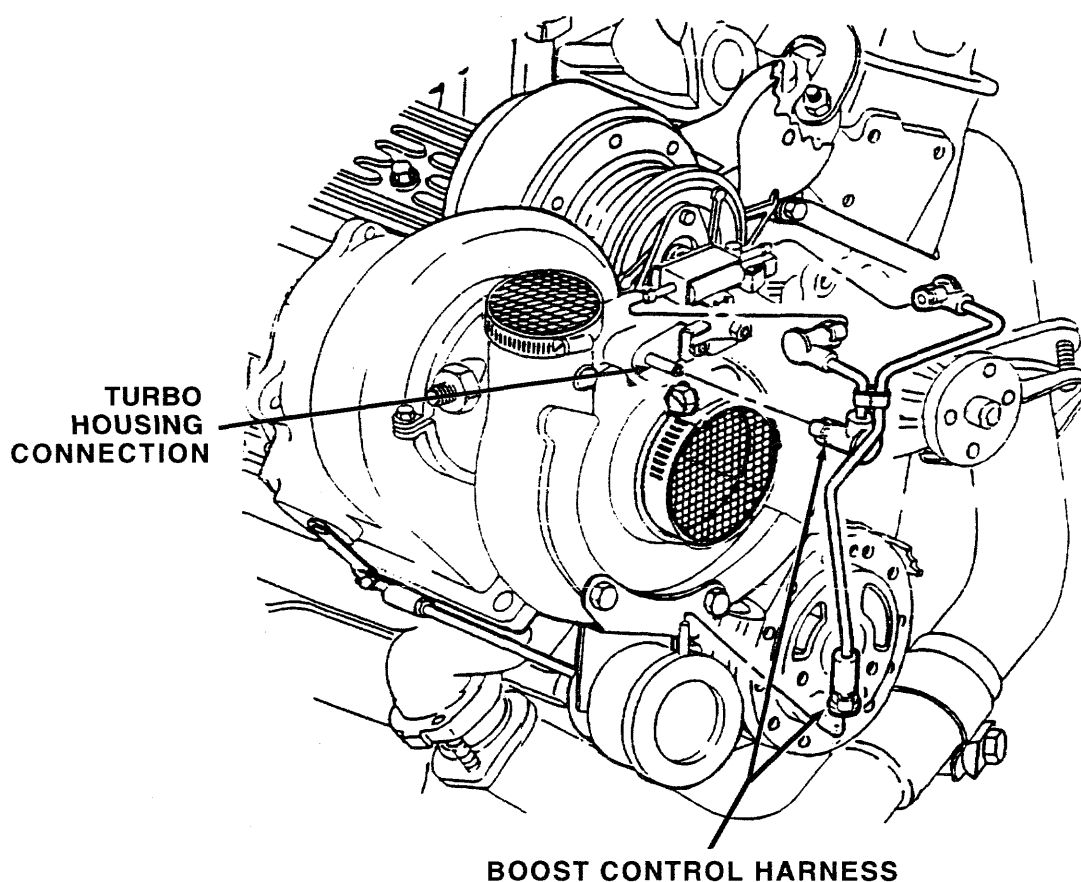
- The Boost Control Harness (located on the turbocharger) installs to the compressor housing with a rubber elbow. If this elbow is forced on to the compressor so that the rubber actually touches the aluminum compressor housing, the boost control cannot operate correctly since the hose nipple is bottoming inside the elbow and blocking off boost pressure. With a screwdriver, pry between the compressor housing and the rubber elbow to obtain approximately 1/8 of an inch clearance.

**NOTE:** Removal of muffler or catalytic converter will cause Code 31 due to a boost "spike".

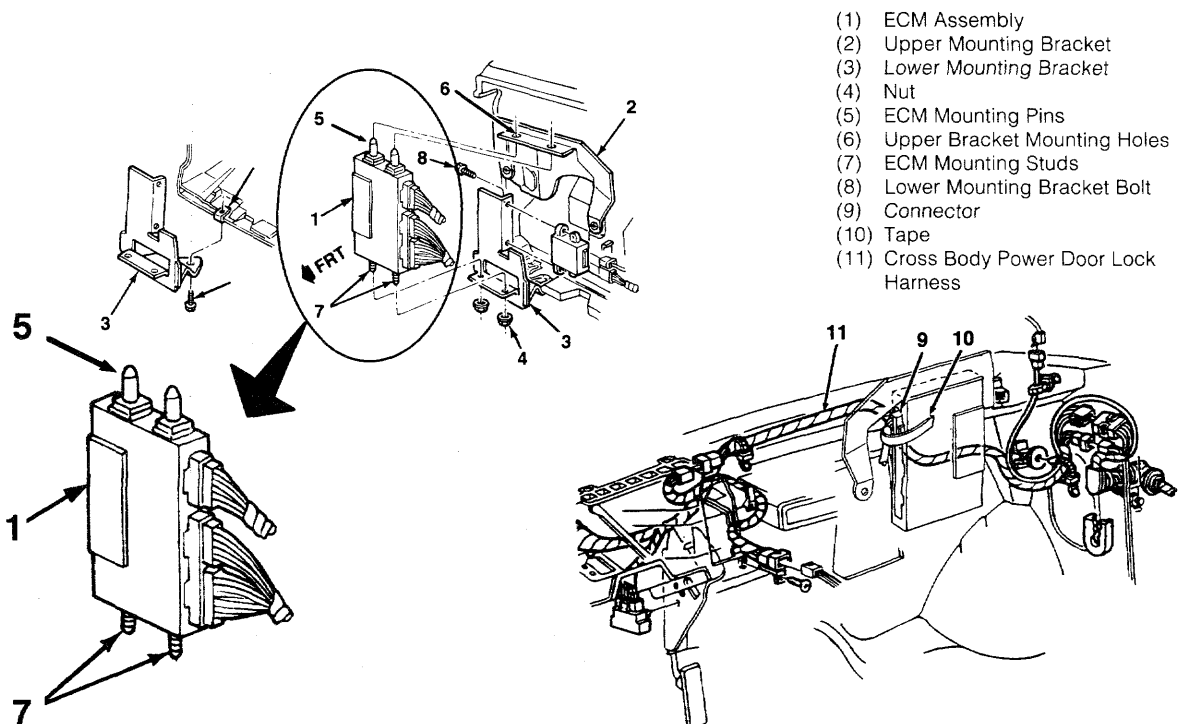
Syclones built before VIN 1521 may experience overboost due to ECM wiring harness chaffing against the upper mounting bracket. It is necessary to repair the wires and install a new mounting bracket assembly to correct this condition. (Campaign 91-C-12.) NOTE: Normally this chaffing occurs with the green/white to black wire.

- 1 Disconnect the negative (-) battery cable.
- 2 Disconnect ECM wiring harness.
- 3 Remove the ECM from the upper bracket.
- 4 Remove the upper mounting bracket.
- 5 Repair the "chaffed" wiring harness in the approved GM manner.

- 1 Mount upper mounting bracket (2) to the I.P.
- 2 When installing the ECM into the passenger compartment, position the wire out of the top (green) connector (9) between the connector thumb latch and the tab on grey comb. IMPORTANT: Place tape (10) to retain wire in this position during ECM installation. To avoid interference, it will be necessary to move the cross body power door lock harness (11) prior to ECM installation.
- 3 Mount the ECM (1) into the upper mounting bracket (2) by inserting the ECM mounting pins (5) into the upper bracket mounting holes (6).
- 4 Secure the lower mounting bracket (3) to the I.P. using the lower mounting bracket mounting bolt (8).
- 5 Install right hush panel.
- 6 Reconnect negative (-) battery cable.
- 7 Verify all ECM functions with a Tech Scan tool.

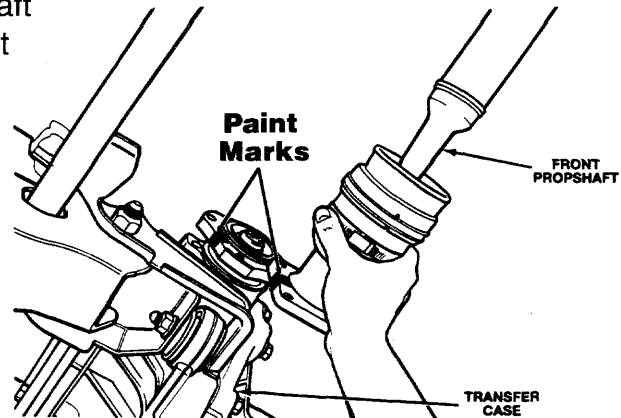
- When replacing the front propshaft in either a Syclone or Typhoon, it is critical that the white painted stripes on the front axle flange and the propshaft are lined up and that the propshaft is seated properly against the flange before the bolts are installed. If one or both of these steps are not done, the result could be vibration.
