Driveability
And
Service:
Typhoon And
Syclone

REFERENCE #GMCTT-92-06-2

REFERENCE
MANUAL

LEADER GUIDE

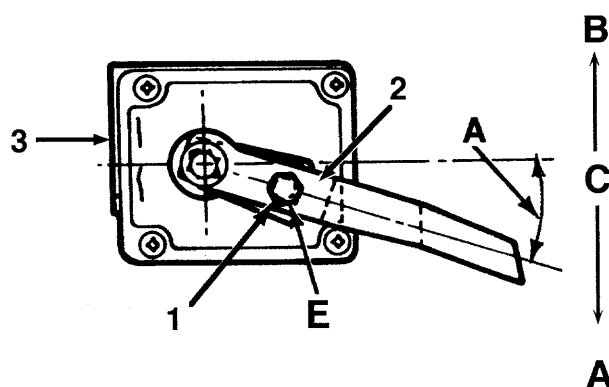
- (1) Lock Bolt
- (2) Plastic Actuating Arm
- (3) ELC Height Sensor

- 1 Loosen the lock bolt (1).
- 2 Adjust the plastic actuating arm (2) up or down depending on the correction:
 - TO RAISE the vehicle trim height move the plastic actuating arm (2) upward. Tighten lock bolt (1).
 - TO LOWER the vehicle trim height move the plastic actuating arm (2) downward. Tighten lock bolt (1).
- 3 Measure the new trim height in the above manner and repeat the adjustments, if necessary.
