**GMC**

**SYCLONE**

**MASTER TECHNICIAN  
OVERVIEW**

## **LEADER GUIDE**

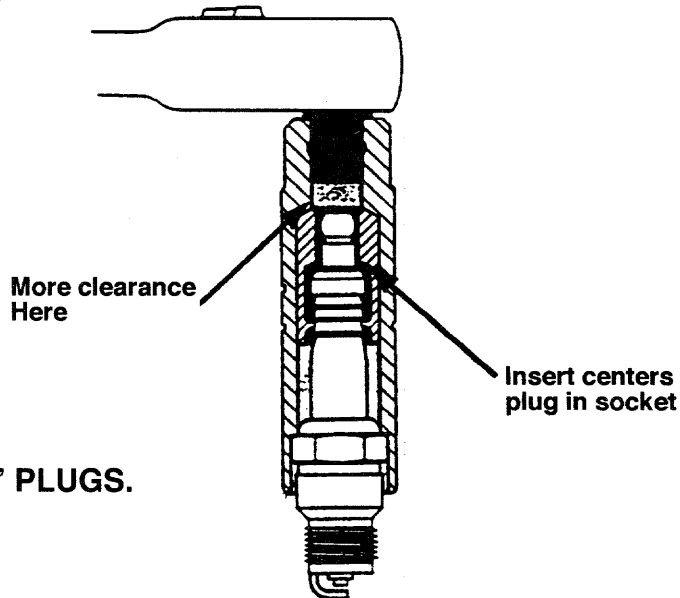
- The Cyclone and Typhoon use the Quantum Plugs, which, among other differences, are longer than the plugs that you routinely work with. Because of this longer length, you'll have to use Snap-On tool #S9706KA spark plug socket or equivalent to service the plugs.

**NEVER REPLACE WITH "HOTTER" PLUGS.**

NOTE: Always replace spark plugs with: CR42TS

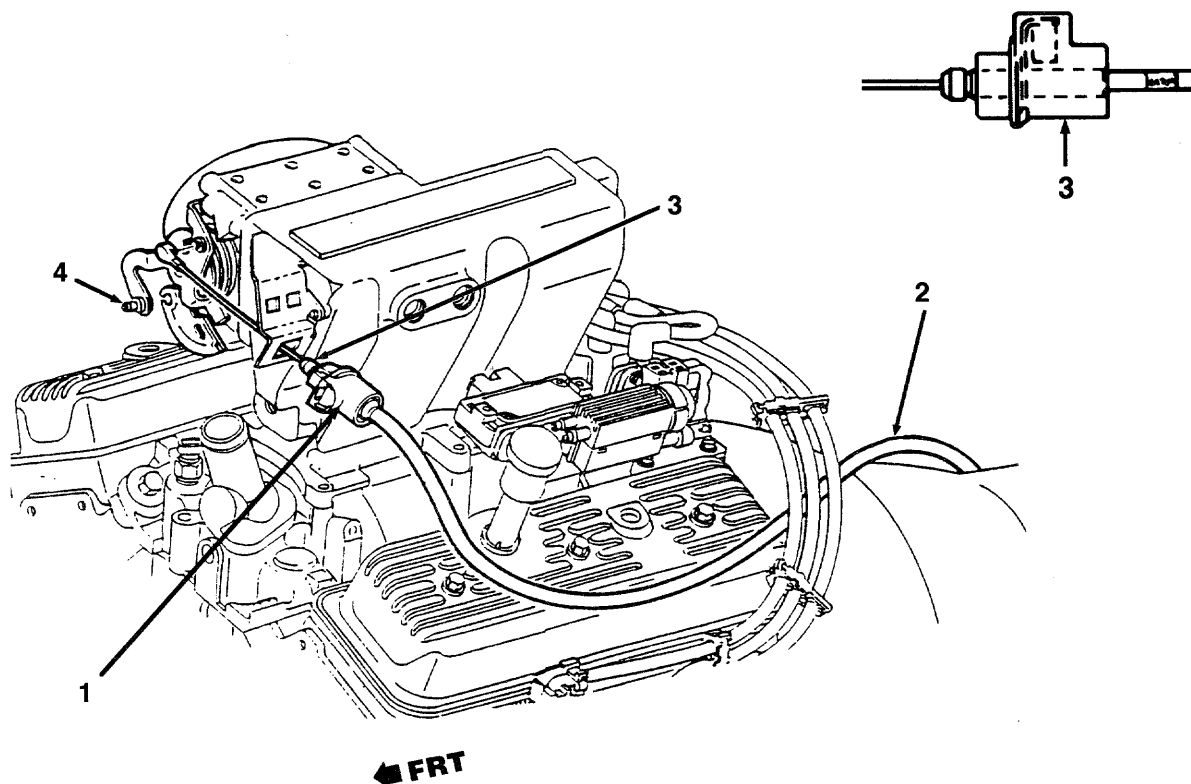
- (1) Re-Adjust
- (2) TV Cable
- (3) Slider
- (4) Throttle Lever

**NOTE:** Check that the cable moves freely. The cable may appear to function properly with the engine stopped and cold. Recheck after the engine is hot.

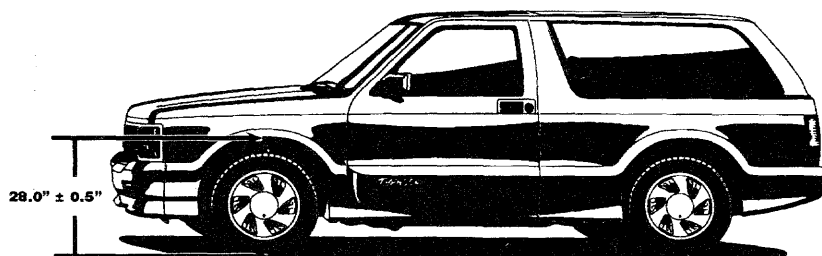
- Measure the distance between the top edge of the front wheel opening and the ground. The correct height should be 28" plus or minus .5". If you find a difference from this height, look for tampering and correct the condition.

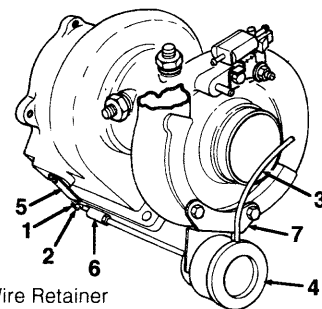
- (1) Wire Retainer  
(2) Lever Pin  
(3) Boost Control Hose  
(4) Wastegate Actuator  
(5) Lever  
(6) Rod End  
(7) Clamp  
(B) 7/8 of diameter of hole on rod end covered by pin

- 1 Install new clamp (7) on boost control hose (3). (These can be obtained through TAC.)
- 2 Connect the boost control hose (3) to wastegate actuator (4).
- 3 Correctly position on hose end and crimp clamp onto hose. Clamp must prevent hose from being capable of pulling off actuator.
- 4 Connect the retaining wire (1) to pin (2).
- 5 Install the passenger side wheelhouse panel.

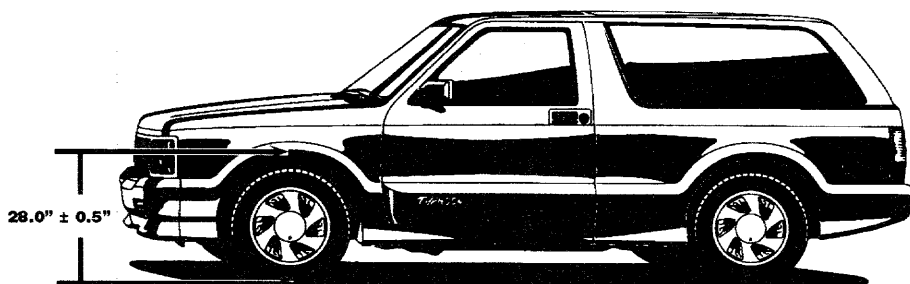
- Measure the distance between the top edge of the front wheel opening and the ground. The correct height should be 28" plus or minus .5". If you find a difference from this height, look for tampering and correct the condition.

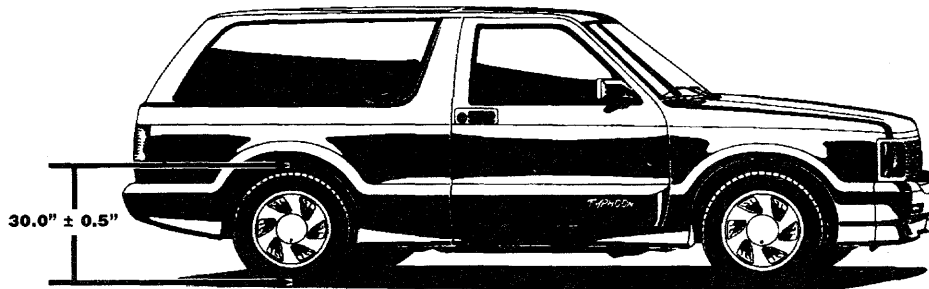
The proper ride height can be determined by measuring the distance from the top of the wheel opening to the ground. The correct height should be 30" plus or minus .5". If you find a difference from this height, look for tampering and correct the condition.

The Cyclone rear trim height cannot be changed. If the actual measurement shows a significant difference from the 30 inches, look for tampering or owner abuse.

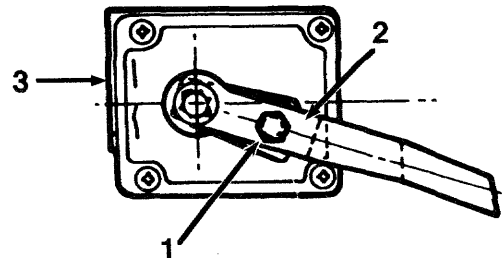
- (1) Lock Bolt  
(2) Plastic Actuating Arm  
(3) ELC Height Sensor

- 1 Loosen the lock bolt (1).
- 2 Adjust the plastic actuating arm (2) up or down depending on the correction:
  - TO RAISE the vehicle trim height move the plastic actuating arm (2) upward. Tighten lock bolt (1).
  - TO LOWER the vehicle trim height move the plastic actuating arm (2) downward. Tighten lock bolt (1).
- 3 Measure the new trim height in the above manner and repeat the adjustments, if necessary.

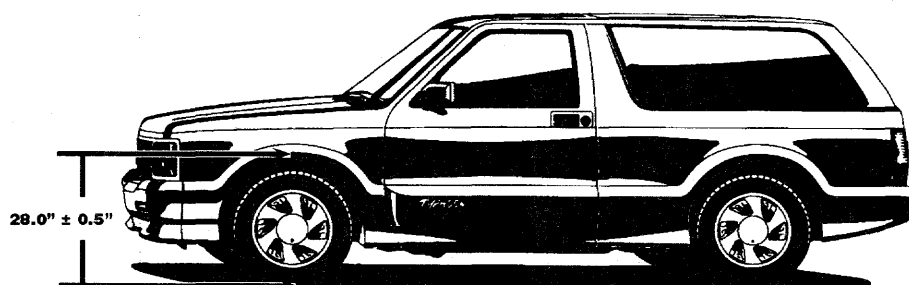
- Measure the distance between the top edge of the front wheel opening and the ground. The correct height should be 28" plus or minus .5". If you find a difference from this height, look for tampering and correct the condition.

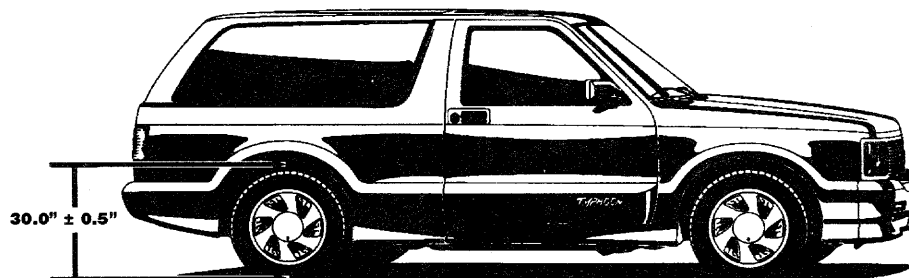
The proper ride height can be determined by measuring the distance from the top of the wheel opening to the ground. The correct height should be 30" plus or minus .5". If you find a difference from this height, look for tampering and correct the condition.

The Syclone rear trim height cannot be changed. If the actual measurement shows a significant difference from the 30 inches, look for tampering or owner abuse.
